ALERT SERVICE BULLETIN

Exchange of turbocharger/exhaust clamps on ROTAX® Engine Type 915 i (Series) and 916 i (Series)

ATA System: 78-10-00 Exhaust system

MANDATORY

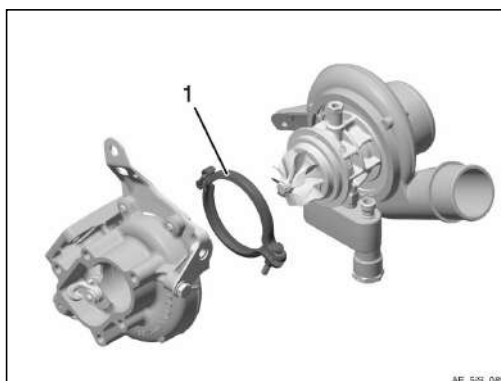
Fig. 1

1. Clamp assy.

Engine type 915 i (Series) and 916 i (Series)

Part no.	Qty/ engine	Description	Application
651873	1	clamp assy. 83 mm	Turbocharger hot section
651873	1	clamp assy. 83 mm	Exhaust elbow (916 i Series only)

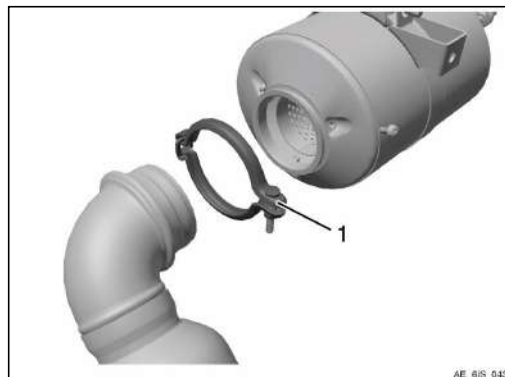
Fig. 2

1. Clamp assy.

Engine type 916 i (Series)

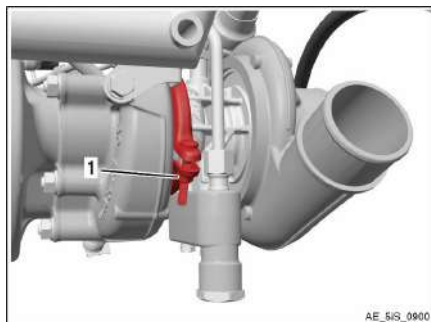
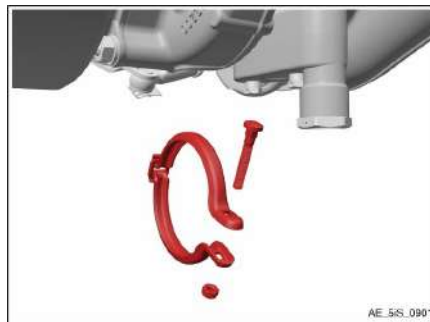
Fig. 3

1. Hex. nut M8

Turbocharger clamp assy.

Step	Procedure
1	Loosen Hex. nut M8 (1) from turbocharger clamp. NOTE: Support the turbocharger center housing and cold section.
2	Remove the clamp.

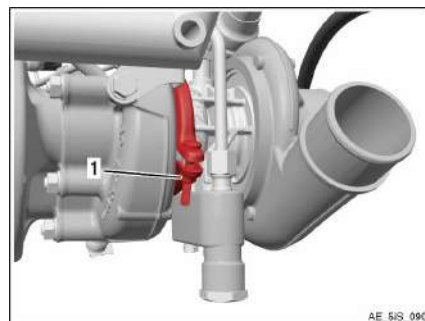
Fig. 4
Turbocharger clamp assy.

1. Hex. nut M8

Step	Procedure
1	Hold the turbocharger center housing and cold section in position on the hot section.
2	Place clamp into position between center housing and hot section, in the orientation depicted.
3	Hand tighten the clamp Hex. nut M8 (1). Check the alignment of center housing and hot section. Tighten clamp Hex. nut M8. Tightening torque 8 Nm (70 in. lb).

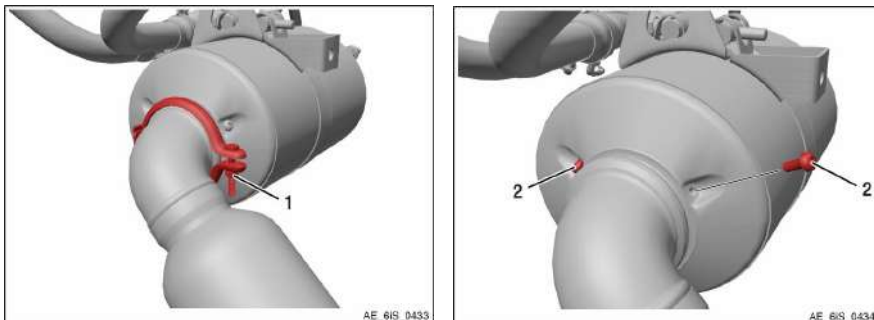
Fig. 5
Exhaust elbow

- 1. Hex. nut M8
- 2. Screw M5x12

Step	Procedure
1	Loosen M8 Hex. nut (1) from exhaust elbow clamp. NOTE: The exhaust elbow is held in position by 3 screw M5x12 (2). See current Maintenance Manual Heavy (MMH) for the respective engine type, Chapters 78-00-00, 78-10-00 and Chapter 78-20-00.
2	Remove the clamp.

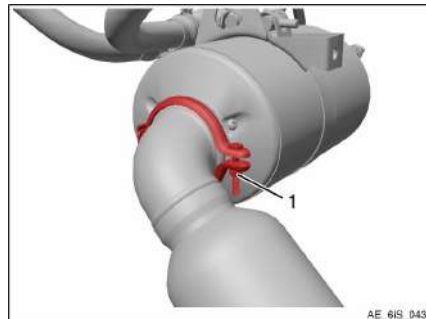
Fig. 6
Exhaust elbow clamp assy.

- 1. Hex. nut M8

Step	Procedure
1	Place clamp into position between the exhaust muffler and exhaust elbow, in the orientation depicted.
2	Tighten clamp Hex. nut M8. Tightening torque 8 Nm (70 in. lb).
